## HUD Projects Summary Sheet

## **Engineering Project #1: 3N01S Timber Retaining Wall and Ditch**

## **Engineering Project #2: 1N96 Culvert Complex**

### **Engineering Project #3: 1N10 Retaining Walls – Lumsden Road**

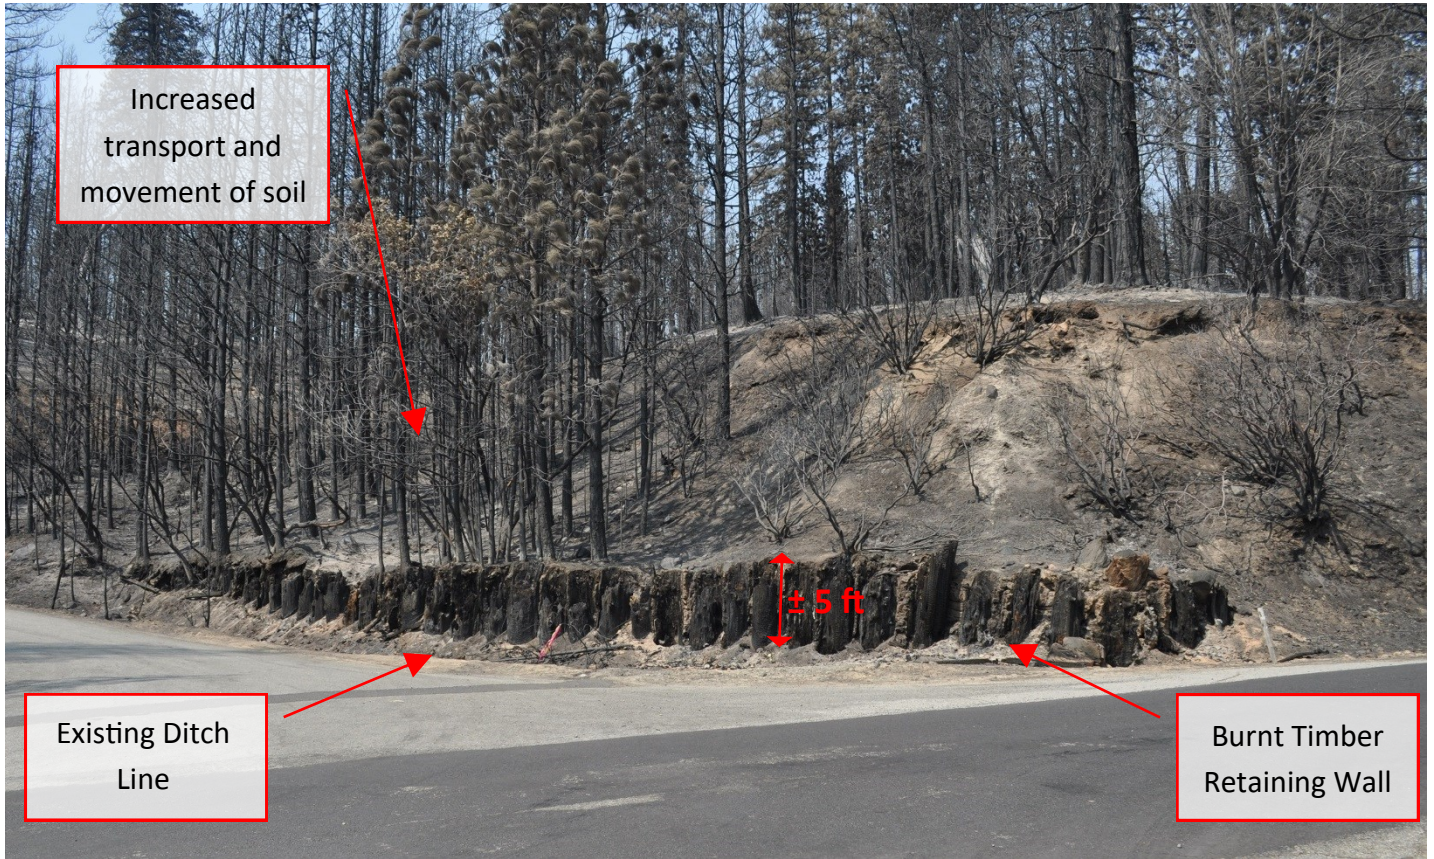
**Engineering Project #1: 3N01S Timber Retaining Wall and Ditch**

**What:** A large soil retaining wall constructed of timber (about 100 feet by 5 feet high at the tallest point) was burned in the Rim Fire. Reduced structural integrity of the wall combined with the potential for enhanced sediment movement into the road and drainage system increases the risk of loss of function of the transportation system at this location. The retaining wall is no longer adequate to protect the road. Loss of function of the burned retaining wall has led to accumulation of material in the roadside ditch.

**Actions:** Engineering retaining wall and drainage design, Prepare construction contract, Administer construction contract, Remove burned timber wall, Installation of new retaining wall and ditch as needed

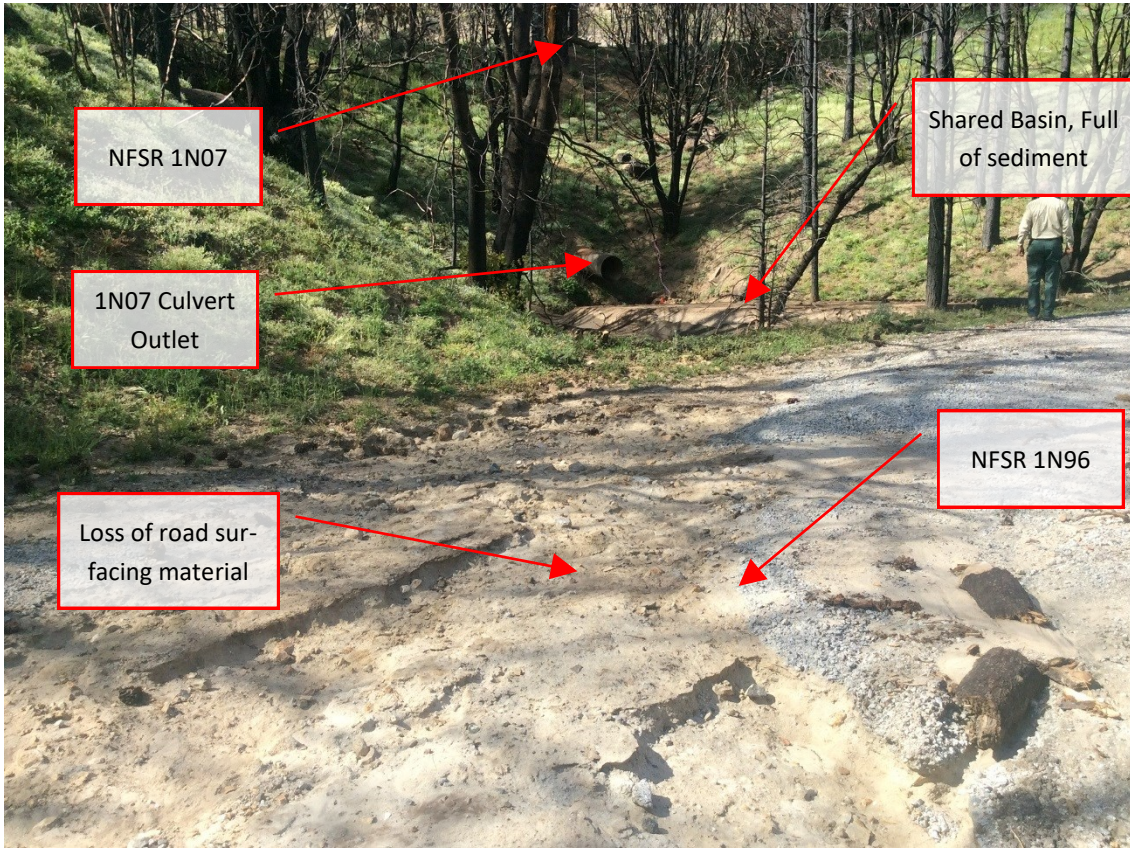
Engineering Project #2: 1N96 Culvert Complex [1 of 2]

**What:** A culvert under Road 1N07 is transporting a large sediment load into the outlet basin, which is shared as an inlet basin for a culvert running under road 1N96. On more than one occasion, the basin has filled with sediment, allowing sediment and water to flow over the road and cause erosion, loss of road structure, and a fill slope washout. The basin has been cleaned of sediment previously, only to be filled up again. The location requires a more permanent fix to accommodate post-burn runoff and these drainage features need to be resized and reconstructed.

**Actions:** Prepare construction contract, Administer construction contract, Excavate, remove and replace culverts under 1N07 and 1N96.

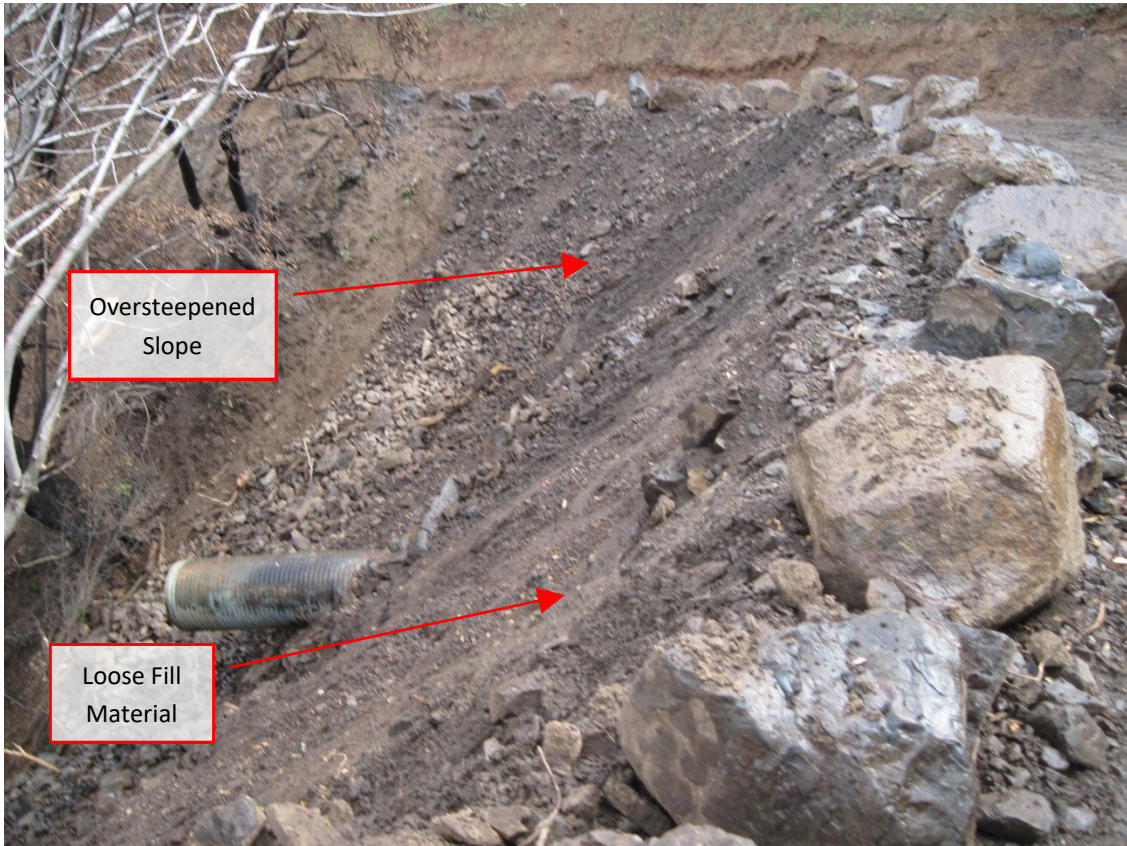
Engineering Project #3: 1N10 Retaining Walls [1 of 2]

**What:** In the first significant storm following the Rim Fire, sediment and large material was transported down the canyon drainage onto road 1N10. Boulders as large as 3 ft. diameter were deposited. In a few cases, the road was severely damaged and the surface was buried. In order to quickly reopen the road for temporary access, the road surface was cleared and re-compacted; and side slopes were armored with large rocks in three locations. The temporary fix works for now, but the repaired fill slope is reported to be "over steepened" in a report from a geotechnical engineer. A permanent, designed solution should be implemented guarantee the long term stability, resiliency, and safety of the road.

Oversteepened Slope

Loose Fill Material

**Actions:** Geotechnical analysis, Engineering design, Prepare construction contract, Administer construction contract, Reinforce retaining walls

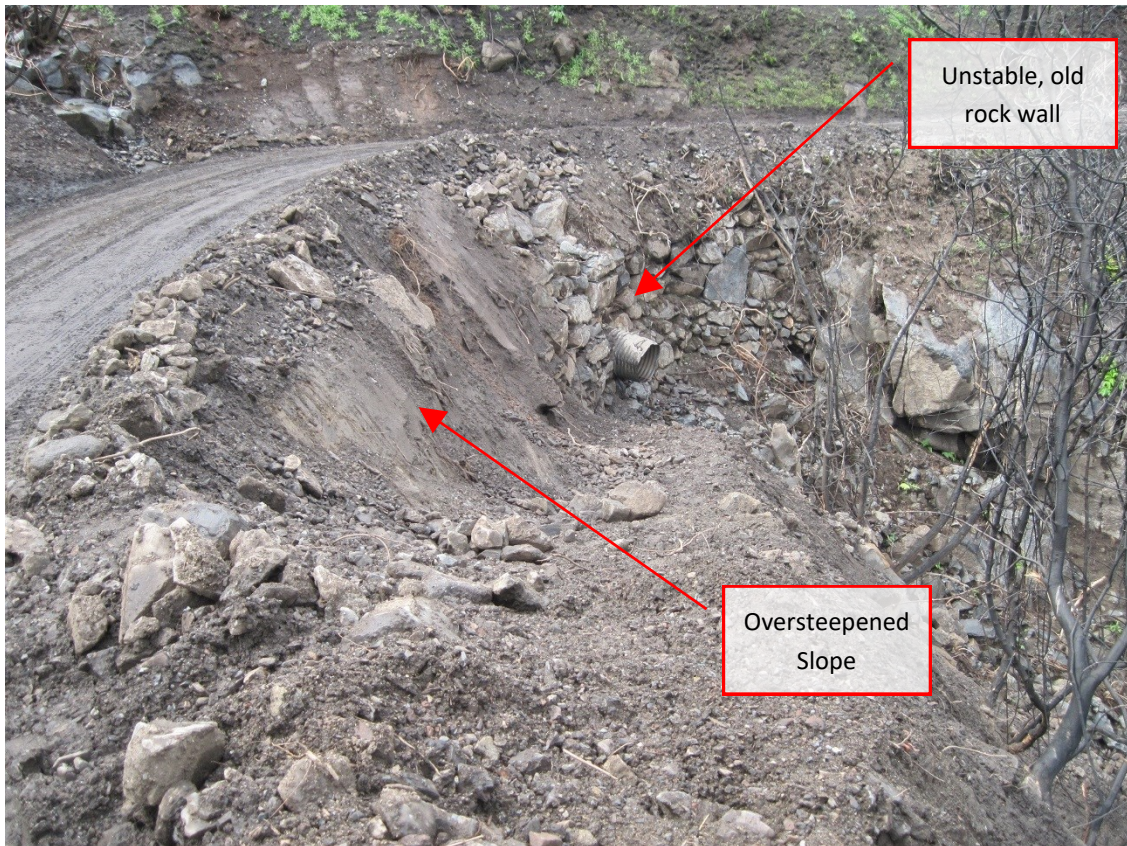
Engineering Project #3: 1N10 Retaining Walls [2 of 2]

Unstable, old rock wall

Oversteepened Slope

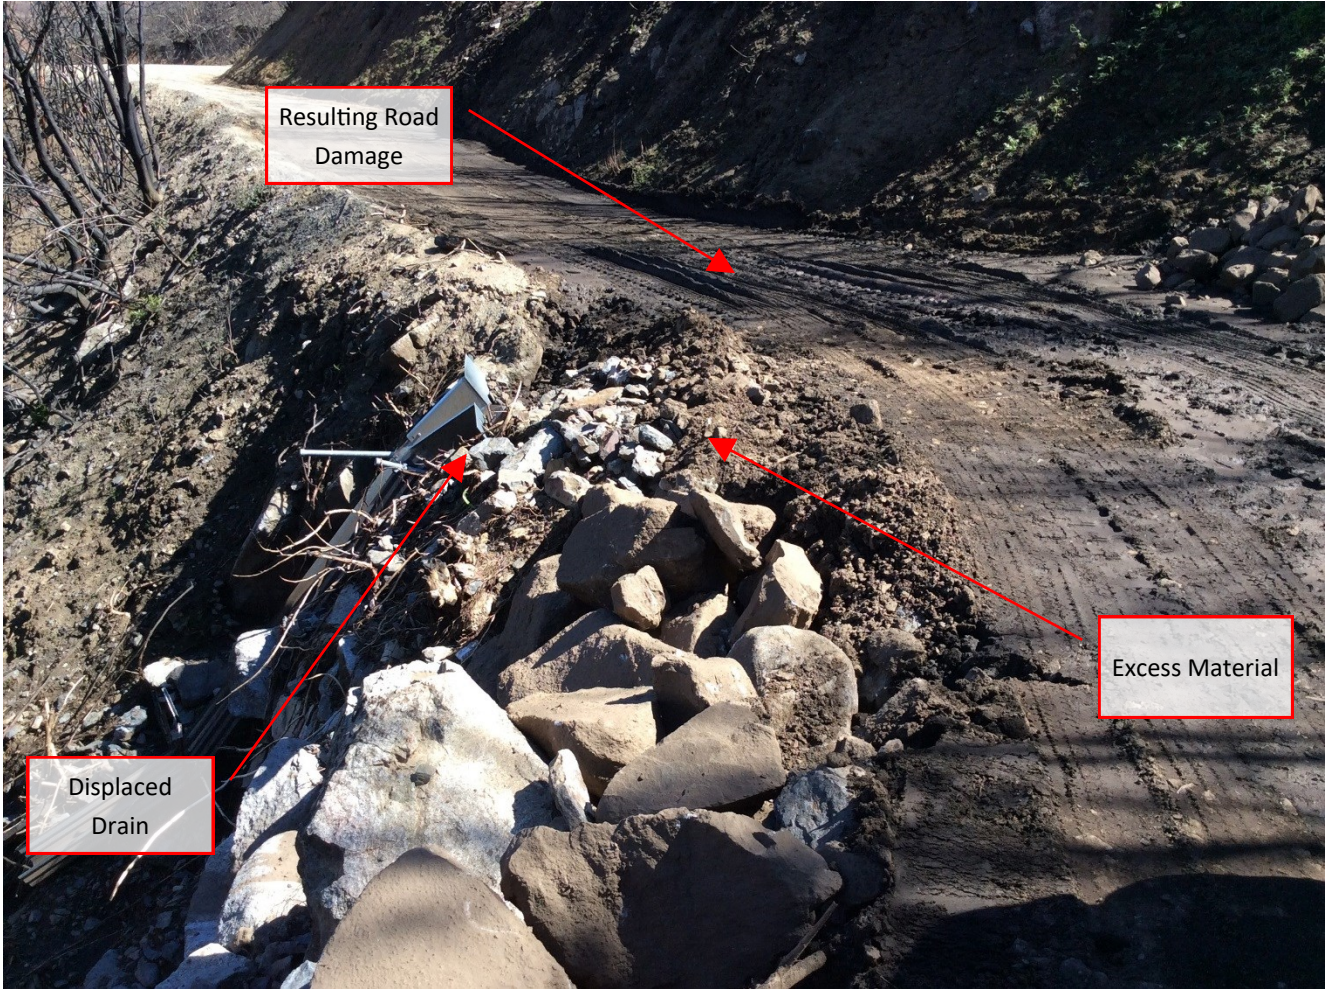
**Engineering Project #4: 1N10 Overside Drains with Intercepting Dips**

**What:** Sediment transport down the drainages increased substantially following the burn. Debris, soil, and rocks moved onto and across the road. Emergency roadwork performed pushed extra material to the outside edge of the road. This material movement affected many of the overside drains. Some were dislodged, damaged, moved, or rendered ineffective. When the drains no longer function, all runoff contributes to the erosion of the road surface and edge.

**Actions:** Prepare construction contract, Administer construction contract, Fix or replace non-functioning overside drains, Add intercepting rolling dips to transport water across road into the overside drains
